## 12. ARCHAEOLOGY AND CULTURAL HERITAGE

This archaeological, architectural, and cultural heritage chapter was prepared by Tobar Archaeological Services. It presents the results of an archaeological, architectural and cultural heritage impact assessment for the extension of operation of an existing wind farm at Carnsore Point, County Wexford. The site comprises largely green field agricultural land.

Planning permission is being sought from Wexford County Council to enable the existing wind farm to continue operating in its current form for an additional 15 years. It is not proposed to alter the current 14 turbine layout or infrastructure and no significant ground works are required. The full scope of works is described in Chapter 4: Description of the Proposed Development.

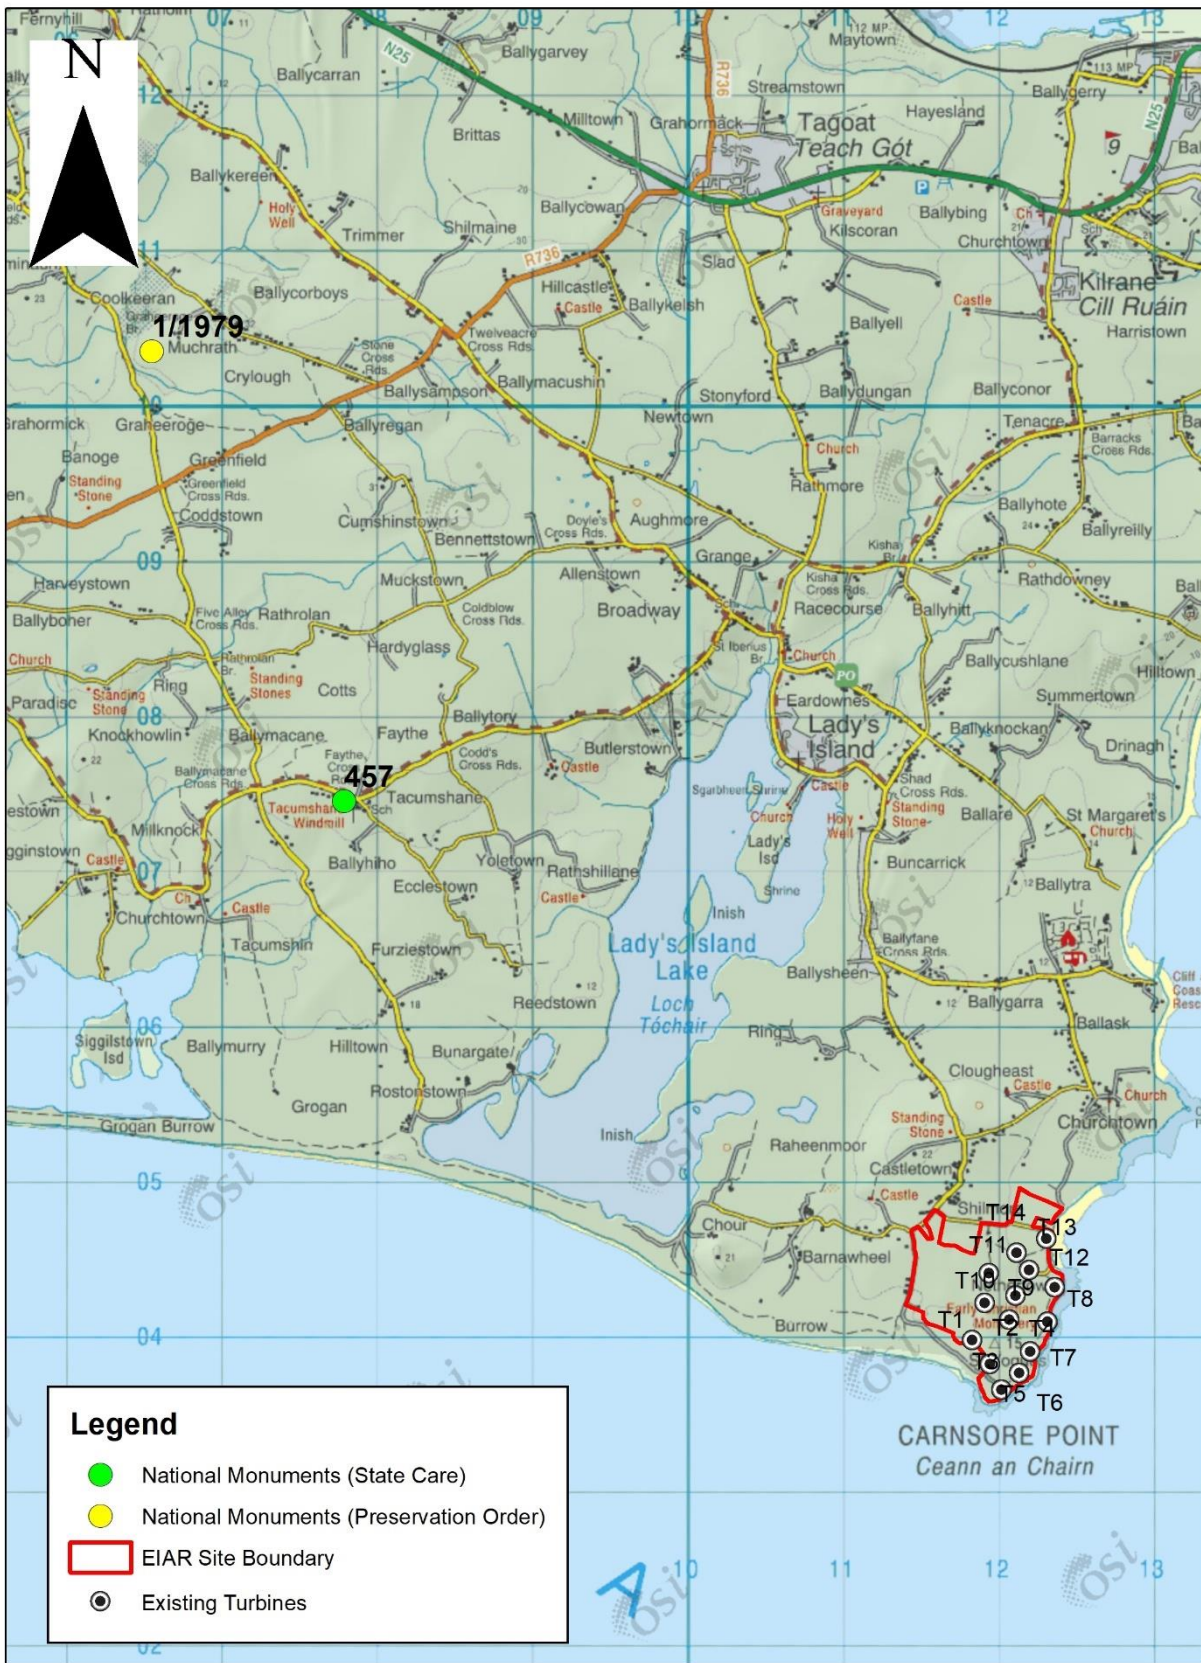
Figure 12-2: National Monuments within 10km of the nearest existing turbine

NM No.	ITM E	ITM N	NAME	STRUCTURE	TD.	SMR REF.	WTG ID	DISTANCE (KM)
457	707707	607504	Tacumshane	Windmill	Fence	WX053-006	T11	5.1
1/1979	706467	610407	N/A	Ringfort	Muchrath	WX048-019	T11	8

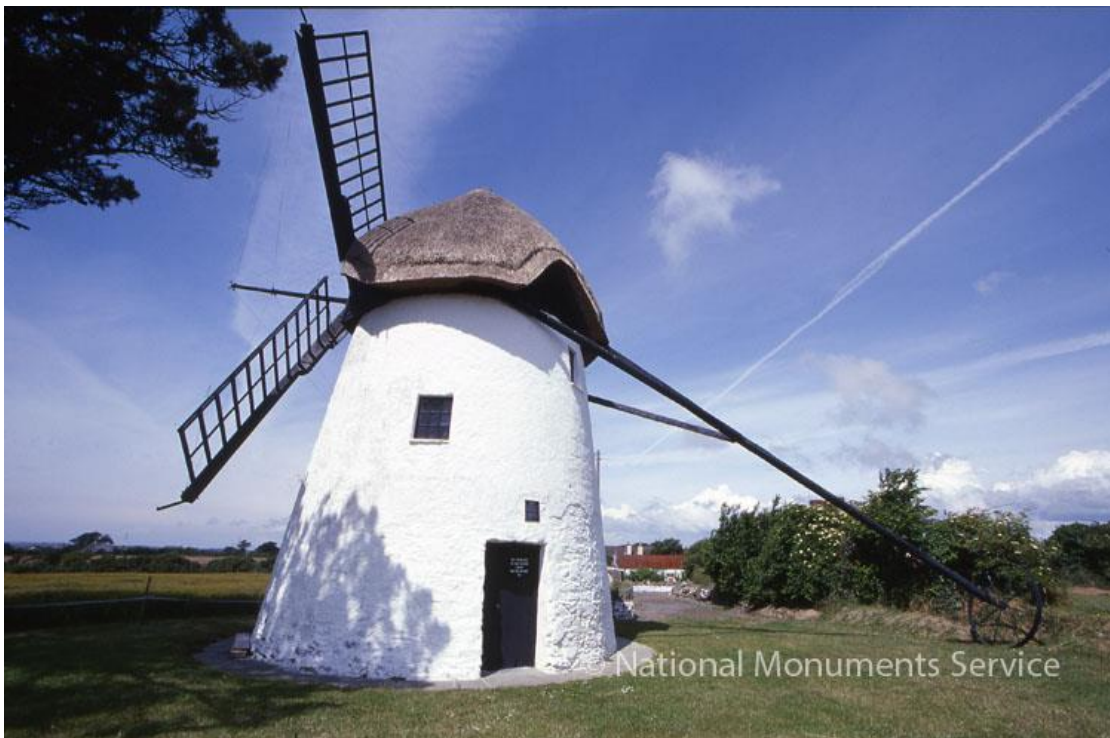
*‘This mill is situated on a level landscape, and has the date 1846 inscribed on the lintel of its E doorway. It was built by James Moran, a millwright who had trained in Holland, and he made and installed all the wooden parts. This was one of about five working mills in Co. Wexford by 1911, but it was roofless by the 1930’s when it was acquired by Gerald Murphy, who replaced damaged parts of the machinery with iron parts from Ballyfane windmill (WX053-080—) and had the building re-thatched. This care allowed it to continue working until 1936 and ensured it survived intact into the 1950s, by which time it was owned by Michael Myler, a nephew of Mr Murphy (Bowie 1974). As the last intact windmill in the country it was conserved as a National Monument in the 1950s (Tacumshane Windmill). (Harbison 1970, 249).*

*This is a tapering tower (ext. diam. c. 6m) of three storeys with walls that taper with height (With at base c. 0.85m; With at top c. 0.4m). It has opposing doorways at E and W, and three floors. The joists of the first floor are set directly into the wall, but those of the second floor rest on a rebate. The cap was turned manually, and the two pairs of millstones on the first floor were under-driven. The remains of the corn-drying kiln are nearby. (O’Sullivan c. 1975). This is a National Monument in state guardianship: No. 457’.*

Plate 12-1: Tacumshane Windmill from the east (Photo courtesy of the National Monuments Service).

The windmill is located on private land to the rear of a number of farm / private dwellings. Hedgerows and boundaries are such that the monument is screened in many directions in particular towards the south-east in the direction of the proposed windfarm. Potential impacts are discussed in Section 12.4.

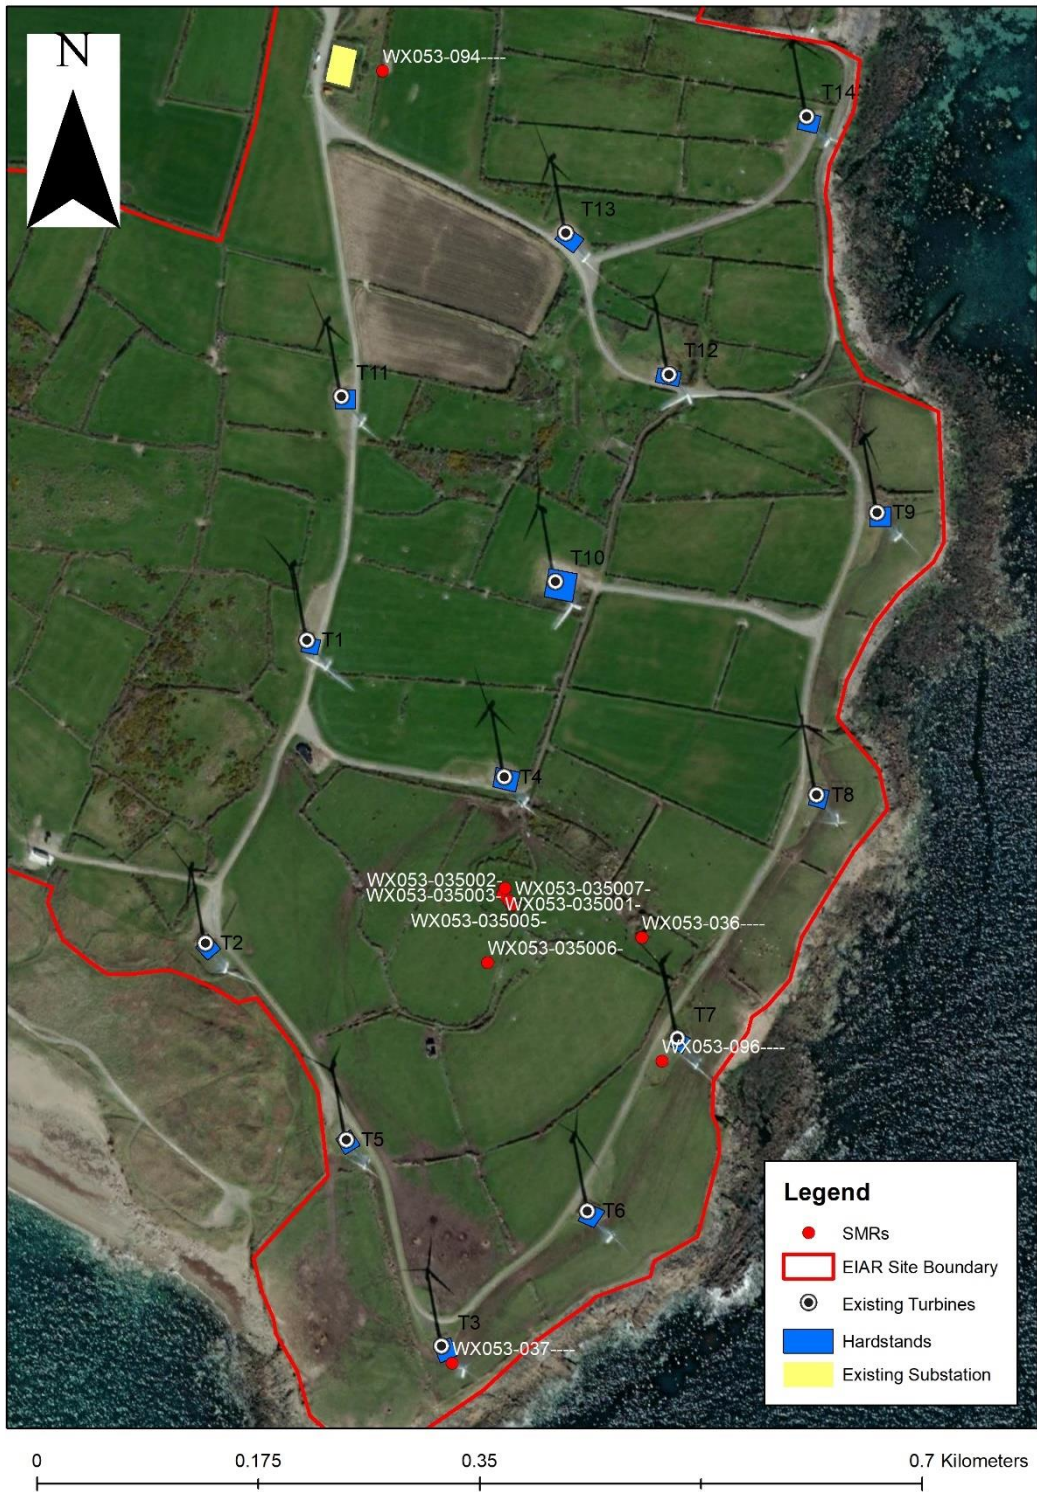
Figure 12-3: SMRs within site boundary.

SMR NO.	ITM E	ITM N	DESCRIPTION	TOWNLAND	WTG ID	DISTANCE (M)
WX053-035002-	711991	604070	Church	St. Vogue's	T4	93
WX053-035001-	711993	604075	Ecclesiastical enclosure	St. Vogue's, Nethertown	T4	88
WX053-035003-	711993	604075	Graveyard	St. Vogue's	T4	88
WX053-035005-	711998	604062	Hut site	St. Vogue's	T4	101
WX053-035006-	711979	604016	Enclosure	St. Vogue's	T4	148
WX053-035007-	711996	604065	House - medieval	St. Vogue's	T4	98
WX053-037—	711951	603699	Megalithic structure	St. Vogue's	T3	16
WX053-096—	712117	603938	Excavation - miscellaneous	Nethertown	T7	22
WX053-036—	712101	604036	Ritual site - holy well	St. Vogue's	T7	84
WX053-094—	711896	604722	Ring-ditch	Shilmore	T13	193

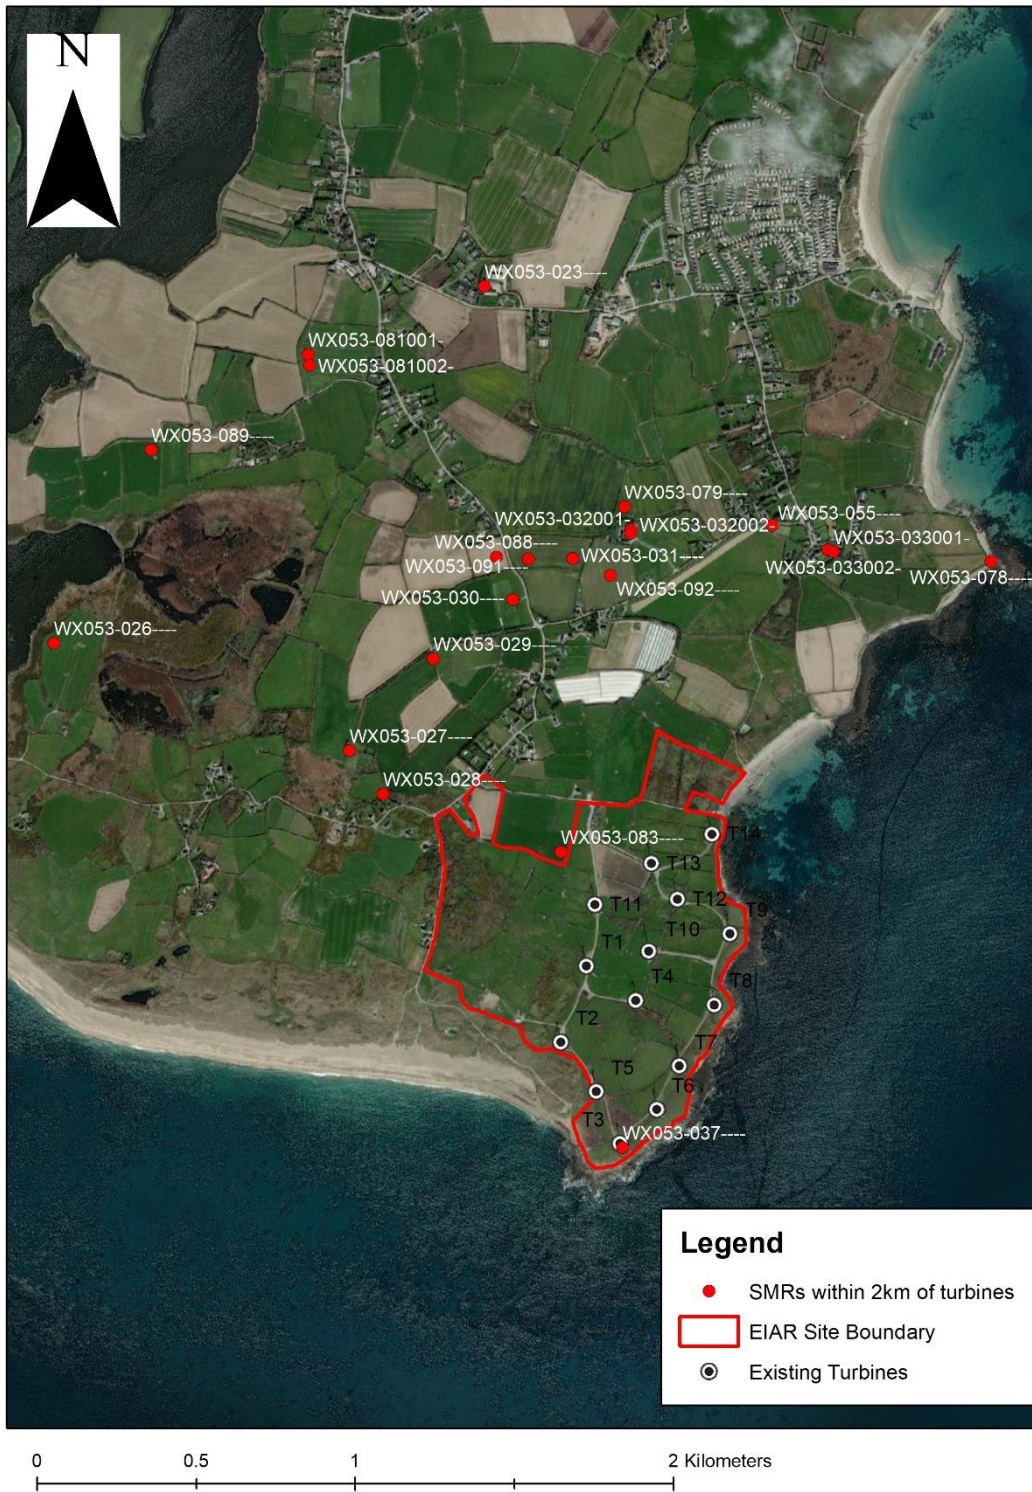
Figure 12-4: RMPs within 2km of the nearest turbine.

WX053-055—	712421	605658	Windmill	Clougheast	T14	990
WX053-078—	713109	605543	Excavation - miscellaneous	Churchtown (Forth By., Lady's Island Ed)	T14	1227
WX053-079—	711956	605715	Burnt mound	Clougheast	T14	1065
WX053-092—	711913	605500	Ringfort - rath	Clougheast	T14	874
WX053-023—	711517	606409	Castle - unclassified	Castlepaliser	T14	1865

SMR NO.	ITM E	ITM N	DESCRIPTION	TOWNLAND	WTG ID	DISTANCE (M)
WX053-033001-	712597	605580	Church	Churchtown (Forth By., Lady's Island Ed)	T14	966
WX053-031—	711794	605553	Ringfort - unclassified	Clougheast	T14	971
WX053-032001-	711976	605632	Castle - tower house	Clougheast	T14	980
WX053-033002-	712613	605575	Graveyard	Churchtown (Forth By., Lady's Island Ed)	T14	967

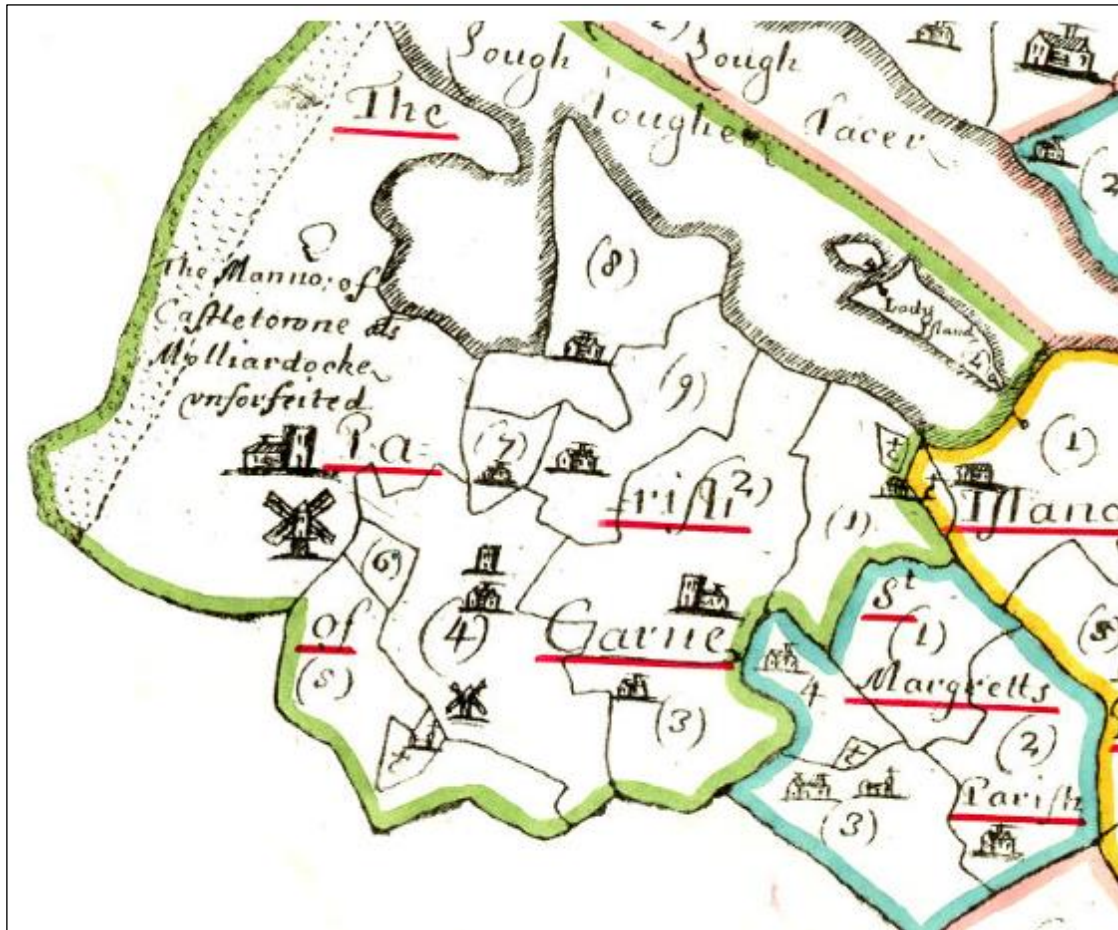
Figure 12-5: Down Survey map ([Down Survey Maps](http://DownSurveyMaps.com) / [The Down Survey Project \(tcd.ie\)](http://TheDownSurveyProject.com))

The Down Survey map for ‘Carnsore point in the barony of Forth (Figure 12-5) shows the area named Carne with a number of windmills depicted within the Barony.

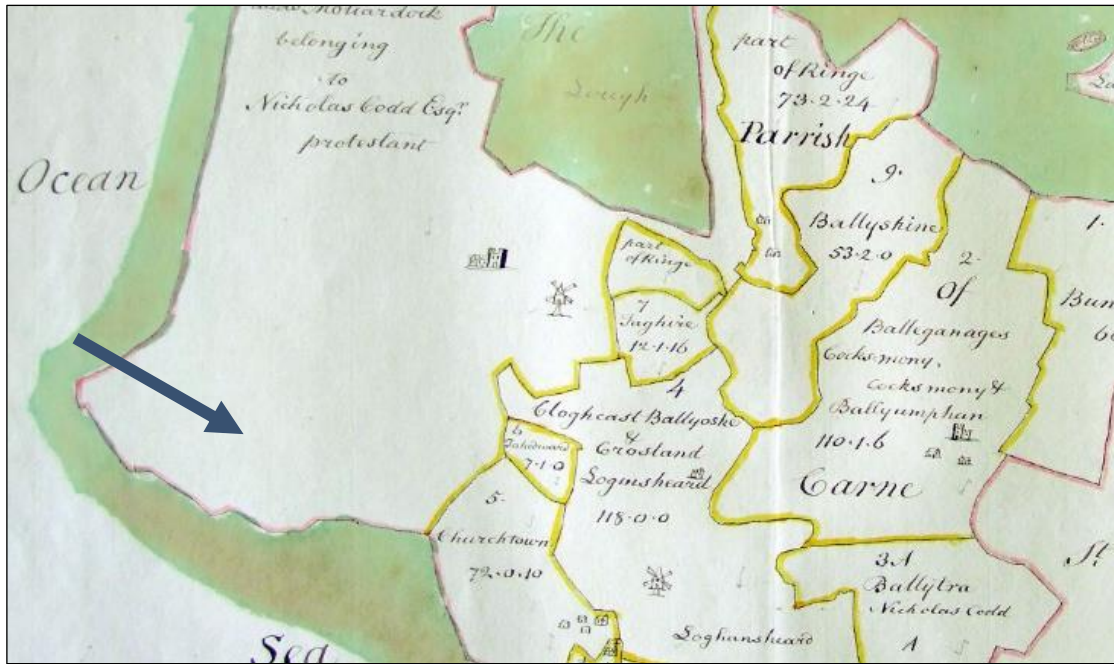
Figure 12-6: Down Survey Parish map of Carn showing vacant space where the wind farm site is located. Note windmill and castle in Castletown townland to the west (upper side of map).
